INVESTIGATION AND REPAIR OF HEAT EXCHANGER FLANGE LEAK

Dennis Martens
The Pritchard Corporation
Overland Park, Kansas

Michael A. Porter
Dynamic Analysis
Leawood, Kansas

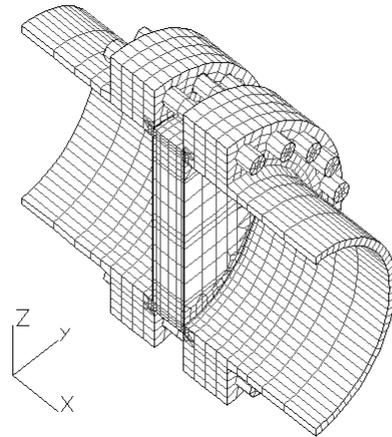
FIGURE 3 -THERMAL MODEL

A thermal model comprised of approximately 6880 three dimensional solid brick elements was used to compute the temperature distribution in the flange system. Figure 3 illustrates the geometry of the thermal model. As may be seen, the symmetry about the vertical axis was used to cut the number of elements that might have been required by a factor of two. The vessel shells were modeled to a distance of approximately one diameter from the flange and terminated with boundary conditions. Although a shorter length of the shell would have been indicated by Saint Venant's principle, the longer length was

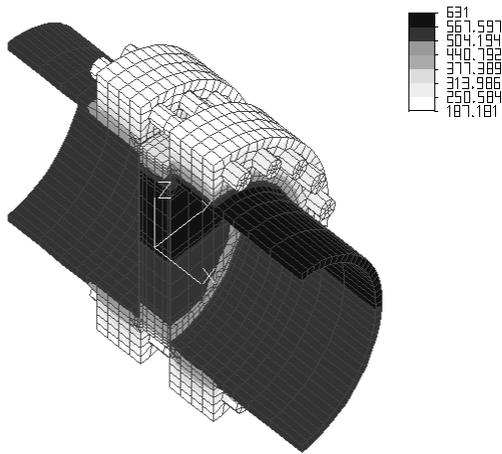
FIGURE 4 TEMPERATURE DISTRIBUTION IN FLANGED CONNECTION (^{O}F)

The inlet and outlet fluid temperatures as well as the surface temperatures at several locations on the joint were obtained from the operating personnel. The conductive film coefficients on the model were adjusted so that the surface temperatures matched the field data with the applied internal temperatures. The resulting temperature distribution in the joint system is illustrated in Figure 4. As may be seen, there was a significant temperature gradient indicated in both the tube sheet and the flanges.

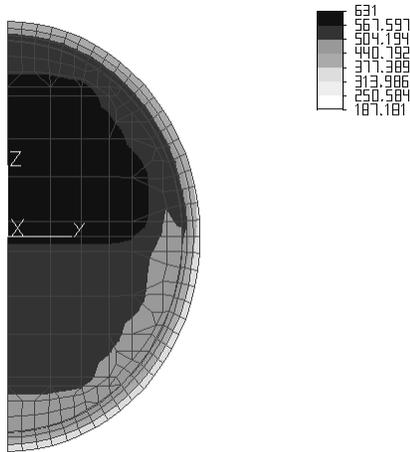
FIGURE 5 TEMPERATURE DISTRIBUTION IN TUBE SHEET (^{O}F)

Figures 5 and 6 illustrate the temperature profiles in the tube sheet and flanges respectively. It is instructive to note that while the range of temperatures in the tube sheet is nearly the same as in the flanges, the relative distribution is quite different. Most of the tube sheet is at a relatively high temperature while only a small outer ring is at a lower temperature. In the flanges, almost the opposite is true. Most of the flange is at a relatively low temperature, while a small portion at the interior of the flange is at an elevated temperature. These temperature distributions are responsible for the differences in the thermally induced radial growth between the tube sheet and flange that will be discussed in the next section.

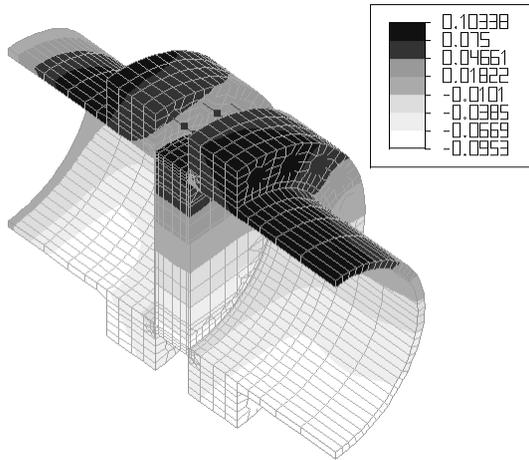
FIGURE 7 - VERTICAL DEFLECTIONS IN JOINT (INCHES)

Figure 7 illustrates the deflections in the model in the vertical direction. As may be seen, the deflection (expansion) of the tube sheet is greater than that of the flange. This differential deflection causes a scuffing of the gasket between the flange and the tube sheet. Due to the complexity of the temperature distribution in the tube sheet and, to a lessor extent, the flanges, the magnitude of

the radial scuffing is not a constant around the circumference of the vessel.

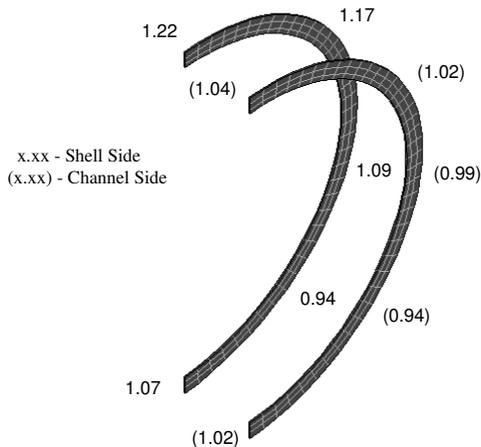
FIGURE 8 - GASKET SCUFFING (mm)

Figure 8 illustrates the magnitude of this scuffing at selected locations on the gaskets between the tube sheet and the two flanges. As may be seen, the scuffing value varies by approximately 30% between the locations selected. Since the selected locations are simply at 45 degree intervals around the circumference, it is possible that the actual variation is even higher. The scuffing and/or the differential scuffing of the gasket is clearly a problem for this joint. This result confirms the preliminary qualifying calculations.

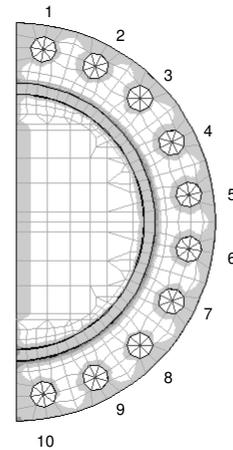
FIGURE 9 - BOLT LOCATIONS AND NUMBERING

Since the bolts in the field unit had become loose and required retorqueing after start-up, the force and stress in the bolts during operation was of significant interest. Although all of the bolts were carefully torqued to the same value before start-up, it seemed likely that there would be a difference in the loads on the individual bolts due to the loading conditions. Figure 9 illustrates the locations of the bolts on the flange model and a numbering system used to identify specific bolts.

Table 2 illustrates the stress in, as well as, the indicated force in each of the bolts for the 6 load cases examined. The initial preload condition indicates that the load in the bolts was uniform with a stress level near the allowable for the B8M bolts. In Load Case 2, where the temperature load is applied, the indicated stress in the bolts is well over the yield for this material. Thus, the bolts would be expected to stretch or elongate during this condition. When all loads are applied, the maximum indicated stress in the bolts is over 5.45×10^8 N/m² (79,000 psi). Additionally, the variation in the load from bolt to bolt is approximately 26%. At this point, we might expect some problems with the seal on the gasket due to the uneven loading and the scuffing mentioned in the previous section.

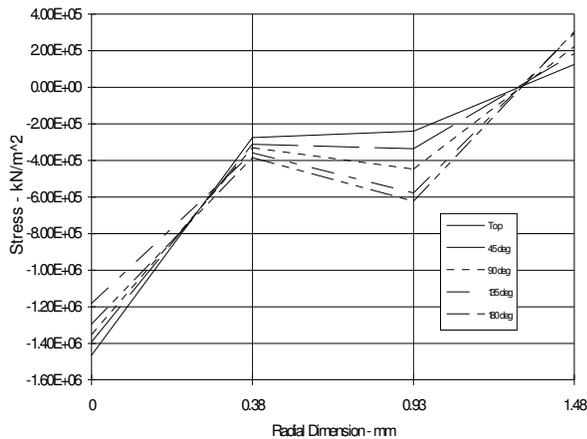
FIGURE 10 - GASKET STRESS - CHANNEL SIDE

Figures 10 and 11 illustrate the computed stresses in the gaskets as a function of the radial dimension of the gasket starting from the I.D. at 45 degree increments around the model starting at the top of the model. Figure 10 illustrates the stresses in the channel side gasket while Figure 11 illustrates the same in the shell side gasket. Note that the inner portion of the gasket (0-0.375 mm) is a solid stainless steel gage ring, while the remainder is the spiral-wound portion of the gasket. Also, it is important to remember that because this was a linear analysis, the actual stress levels would be considerable lower due to yielding in the material.

The fact that the outer edge of each gasket is indicated to be in tension (a physical improbability at best) makes the absolute values questionable. We may, however, see that there is a general trend toward unloading of the gasket at the top of the flange, especially in the shell side, due primarily to the piping loads. Additionally, the stresses shown here are a result of a linear analysis wherein the bolts have not been allowed to yield. Thus, if we allow for yield in the bolts, the potential for unloading of the gaskets is indicated.

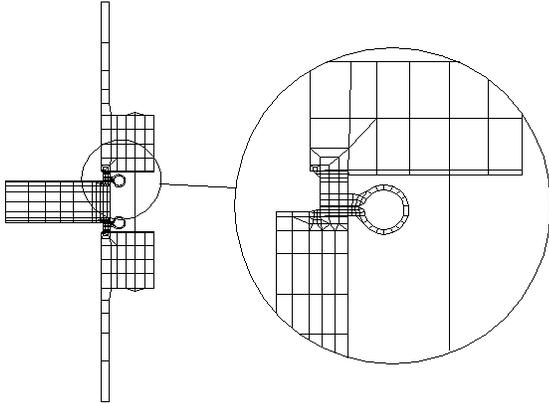
FIGURE 12 - AXISYMMETRIC MODEL

Figure 12 illustrates the geometry of the axisymmetric model. The enlarged view provides more detail of the weld ring gasket geometry. Note that this type of gasket is machined in two separate pieces, mating in the center of the circular portion. The separate halves are welded to the flange and tube sheet faces and then welded together to form a sealed gasket. The interface between the two faces of the gasket was modeled both with non-linear gap elements and with connecting beam elements, as will be discussed in a later section. The bolts in the actual flange are periodic about the axis of symmetry rather than axisymmetric. Therefore, an equivalent beam element was used to model the bolts.

- To control the scuffing problem, a "weld ring" gasket would be used in place of the original spiral-wound gasket.

- Carbon steel bolts with disk spring washers to control the maximum bolt load would be used in place of the stainless steel bolts.

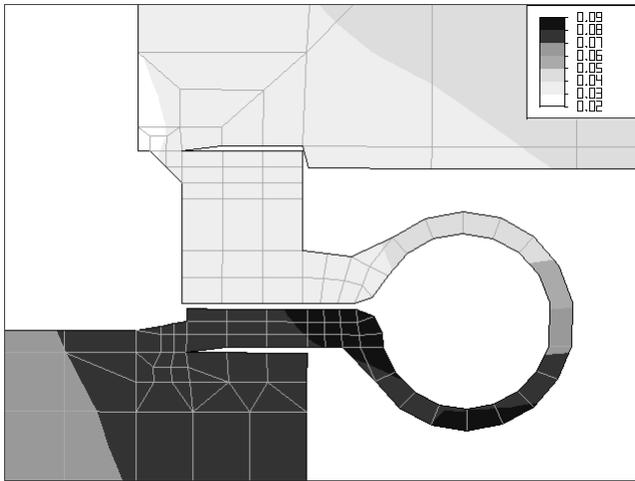
FIGURE 13 - RADIAL DISPLACEMENT (INCHES)

Figure 13 illustrates the radial (scuffing) motion of the two gasket faces for the shell side gasket. The shell side gasket in the axisymmetric model followed the three dimensional model in indicating the highest scuff values. As may be seen, a relative displacement of approximately 1.25 mm (0.05") was indicated between the two surfaces. This displacement was predicated upon the absence of radial force transfer between the surfaces.

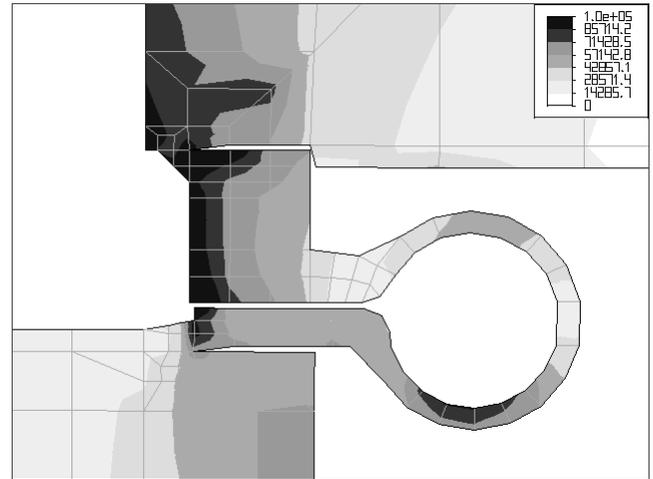
FIGURE 14 - RADIAL STRESS (PSI)

Figure 14 illustrates the radial stress in the shell side gasket based upon a coefficient of friction of 0.4. As may be observed,

there is still an area of elevated stress near the gasket to flange weld. Since the load is a secondary load, however, the 2.4×10^8 N/m^2 (35,000 psi) indicated should not pose a problem. When the coefficient of friction is raised to 0.8, the stresses in this area are nearly doubled. If the frictional force were actually this high, there would be concern for the weld between the gasket and tube sheet. We have concluded that the 0.4 value is probably a best guess for this geometry.
